Kenwood TS-520, TS-820, TS-530, TS-830 Drive Sprocket repair

(Written by: Mark Gilger, WB0IQK)

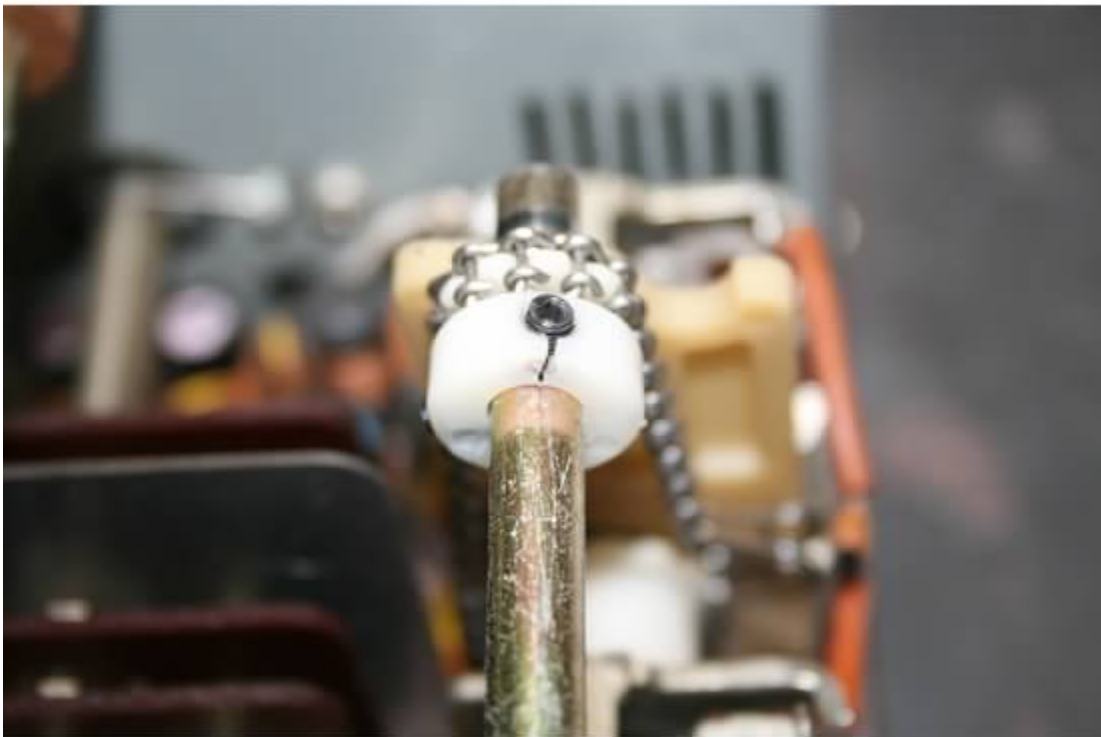
A shortcut to having to remove a cracked sprocket and replacing, if one can actually be found. They are no longer produced and hard to find and used ones are most of the time in the same condition. The easiest method is to repair without having to remove the damaged unit.

The following picture shows a typical unit that's cracked on 1 side.

- First, a suitable adhesive needs to be applied. I've used both Super Glue or a product called E-6000. E-6000 is an industrial strength adhesive that really seems to do a good job on everything I've used it on. http://eclecticproducts.com/e6000_retail.htm. Also Loctite Epoxy Plastic Bonder has been reported to work. http://www.loctiteproducts.com/p/13/7/epxy_plstc_s/overview/Loctite-Epoxy-Plastic-Bonder.htm .
- Apply a small amount of the adhesive on the tip of a toothpick and put that small amount into the exposed crack. Once a suitable amount has been applied, back out the Allen screw to remove the pressure on the sprocket. The crack should close up.

- Put a tie wrap on around the hub and tighten. Let dry for 24 hours.
- Cut the tie wrap off and tighten the set screw, making sure it's just snug and not overly tight.
- Put on a fresh tie wrap as tightly as you can get it. The job is complete and the sprocket should last a long time.

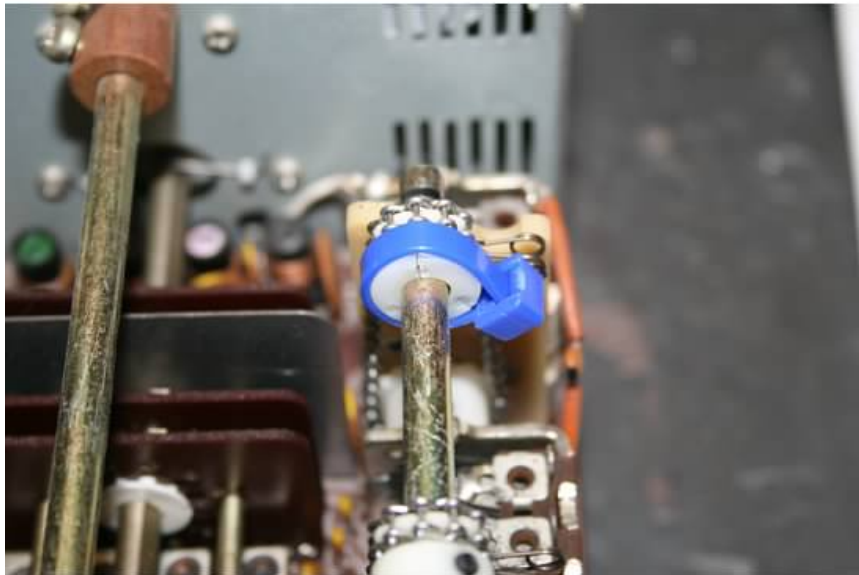
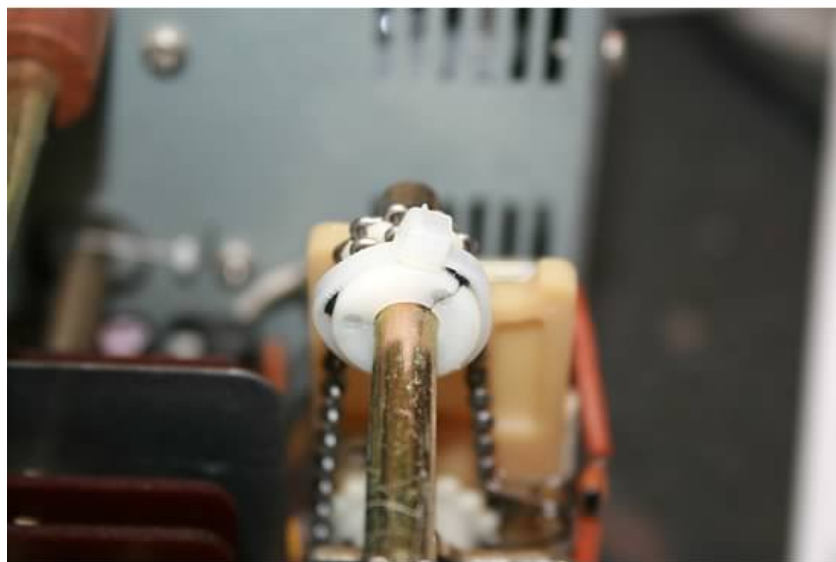
The follow 2 pictures shows the fix utilizing two different sizes of Tie Wraps. The only difference is the size the user prefers to be used.
