## Circuit Improvements for the TS-430S

by Richard L. Measures, AG6K

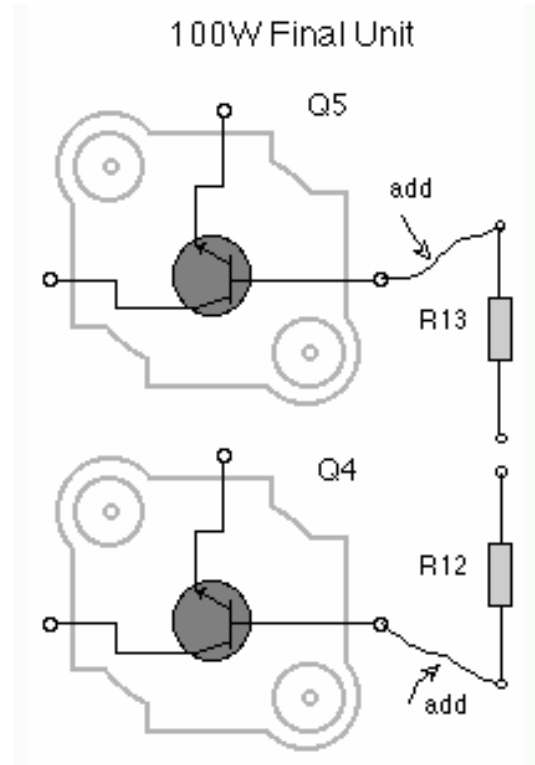
**Problem:** Intermittent ALC during transmit and/or intermittent reduction or loss of power output. The power output can sometimes be restored to normal by turning up the microphone gain or by dropping the radio a few inches. Signal reports of intermittent transmit audio distortion are normal.

**Why:** This problem is caused by repeated thermal expansion and contraction of the cheap, phenolic printed circuit board [PCB] which eventually breaks the two, plated-through the circuit board connections between the output of the 10W driver stage and the input [base] connections to the 100W RF final transistors, Q4 and Q5. When the break occurs, the RF from the drivers does not reach the input [bases] of the final transistors, so there is no load on the driver output transformer, T2. Without a load on its secondary, the peak RF voltage across the primary of T2 runs

wild and breaks down the collectors of the driver transistors. When the driver transistors fail and short, they destroy the bias transistor, Q7, as well. Changing these components is an unpleasant and uncheap job. Worse than that, the same components will most likely fail again unless the real problem on the PCB is taken care of. **Fix:** On the component side of the 100W Final Unit circuit board, install a jumper wire between the (outer) end of R12 that is nearest to the base of Q4 and the base lead of Q4. Install a jumper wire between the (outer) end of R13 that is nearest to the base of Q5 and the base lead of Q5. These two jumper wires make sure that the driver RF arrives at the final amplifier transistors, whether or not the plated-through connections are doing their job.

Another method of fixing the problem is to solder Z-wires in the plated through holes. [a Z-wire is a wire that is passed through the board and whose ends are bent in opposite directions so that it will stay in place during soldering]
