Modifications for the Kenwood T-599
Service Notes on T-599A/D

Trio-Kenwood Communication, inc.

Service bulletin no. 7 (2-11-1977)

Reducing 120Hz hum in T-599D

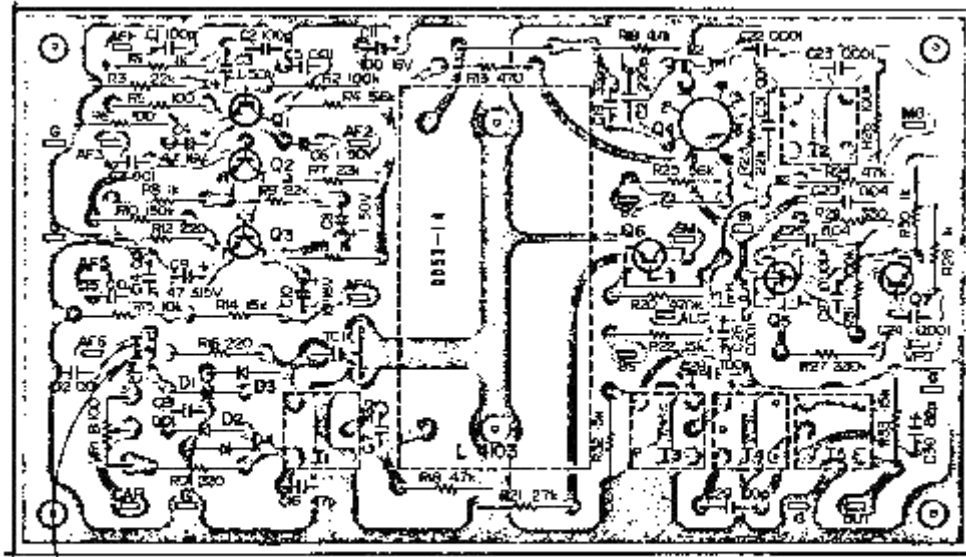
FOIL SIDE OF BOARD

There have been some cases of 120Hz hum in the T-599D. This may be reduced by removing L-1 (1mH) on the generator unit (X52-0009-00) and replacing it with a 47 ohm resistor. Shown below is the generator unit board with this change.
