Circuit Improvements and Maintenance Procedures for the TS-830S

by Richard L. Measures, AG6K

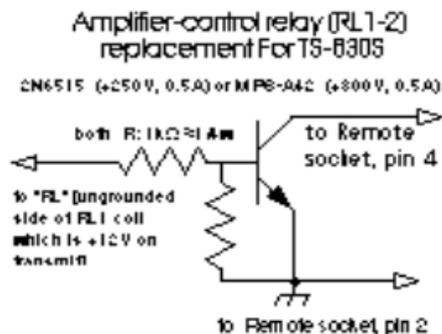
15. Problem: Excessive delay in relay control signal to external amplifier--which causes hot switching in the amplifier's RF relays. Cause: The RF relay in the TS-830S also switches the external amplifier relay control line. Thus, the amplifier relays can not begin to close until the RF-relay in the TS-830S has closed. **Fix:** Install a NPN >200v switch transistor [MPS-A42 or=] in the TS-830S to take over the job of relay control line switching. The input [base] of the switch transistor is driven by the +12V on transmit signal ["RL"] that drives the coil of the TS-830S' RF-relay, RL1. The base-current is limited to approx. 11mA with a 1k Ohm series resistor. Connect another 1k Ohm resistor between the emitter and the base to drain off the stored charge in the base. The emitter connects to chassis-ground. The collector connects to the wire from pin 4 on the Remote socket. Pin 2 of the remote socket should be connected to chassis-ground or to the emitter of the transistor. The NPN transistor can only switch a positive relay-control line voltage, so this circuit will not work on negative relay-control voltage amplifiers like the SB-200 and the 30L-1. The fix is to convert these amplifiers to [standard] positive V relay control line polarity. A solid-state electronic cathode bias switch [ECBS] is useful in this application. Such a circuit is shown in *QST* magazine, January 1994, "The Nearly Perfect Amplifier."
