## Circuit Improvements for the TS-440S

by Richard L. Measures, AG6K

Updated December, 2002

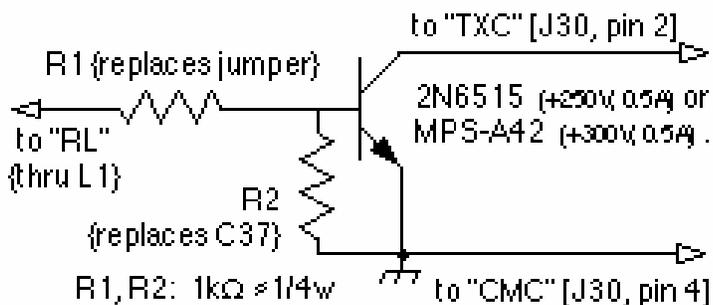
*Amplifier-control-relay (RY2) replacement for  
TS-440S SWITCH UNIT, (N41-1610-00) (N-14)*

**PROBLEM:** The amplifier-keying-relay, RY2 on the (N/14) Switch Unit, makes too much noise, or the contacts on RY2 have burned and pitted, or all of the above. Another problem with RY2 is that it is too slow to use with a full-QSK amplifier. This needless make-delay can cause the amplifier to hot-switch, burning the contacts in its QSK-relays. **FIX:** replace RY2 with an NPN switching transistor and fix the current pulse problem that pitted the relay contacts, which may also damage the transistor. [only works for amplifiers with positive voltage relay control]. If your amplifier uses positive 110V for the relay control, like the SB-220 and the TL-922, the relay pitting is caused by the current pulse from the repeated shorting out of the charged .02 $\mu$ F bypass capacitor across the amplifier's relay control jack. The bypass-capacitor can be removed if shielded wire is used for the interconnection cable to the transceiver. Another fix is to install a 150 Ohm to 200 Ohm, 1/4W series resistor at the relay control jack to limit the discharge current to a value that the relay or switching transistor can handle. The bypass capacitor is connected to the relay-side of the resistor.

**Transistor Installation Notes:** The N/14 Switch Unit is located just behind the ANT RF connector on the rear panel. The small access panel on the bottom, rear of the radio is removed to gain access to the N/14 Switch Unit. Two chassis-ground connections and one center pin connection must be unsoldered from the RF connector before the Switch Unit can be removed. Unplug the three connectors, remove the two sheet metal screws, and lift out the Switch Unit. Unsolder and remove RY2, D16, and the white jumper-wire and the pin that it plugs into. Install one 1k Ohm resistor each in place of D16 and in place of the jumper-wire and its pin. The transistor will solder in place of the relay if its full length leads are bent to fit the available holes. The emitter goes to common-ground, as does the trace to J30, pin4 [CMC], the ground return for the relay control circuit. The base lead connects to the trace that goes to R2 {D16} and C37. The collector solders to the trace that connects to J30, pin 2 [TXC].
