Technical Information Exchange

No: 020

Rebuilding the bandswitch on a Kenwood Hybrid radio – TS-530S and TS-830S

Dick Housden – W0NTA

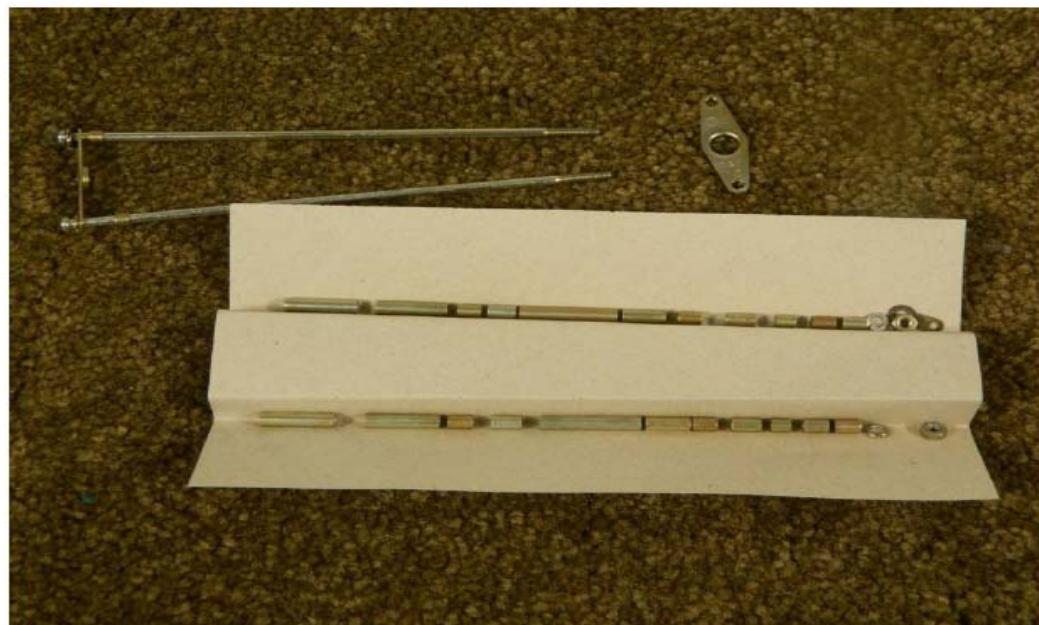
These are the through screws and spacers as removed from the switch assembly.

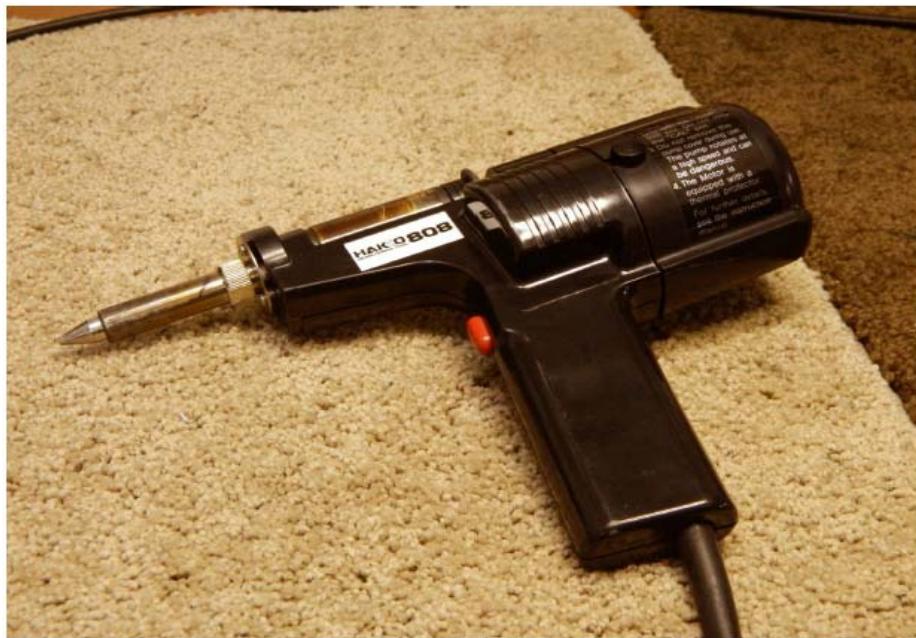
This is the Hakko 808 de-soldering tool. I have owned this one for over ten years and could not function without it. Many will think it is expensive, but it is well worth the money if you do much work on PC boards.

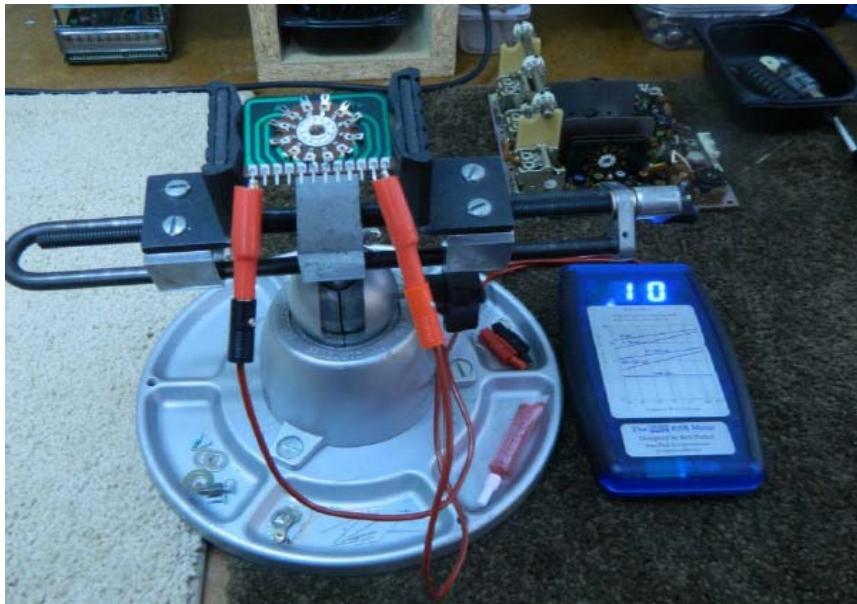
Each contact is checked for high resistance after cleaning. I am using here the Blue ESR meter which will measure quite low resistances. The reading here is .1 ohm. As you get closer to the other probe, the resistances will decrease as it is reading the resistance of the traces on the board. I also check physically for any looseness of the contact on the board. These contacts are originally held in place with rivets and they sometimes loosen.
